# **RESTORATION WORK ON BYZANTINE AND POST-BYZANTINE MONUMENTS IN THE PRESPA AREA - GREECE**

**Kleopatra Theologidou**

Ministry of Culture, 11<sup>th</sup> Ephorate of Byzantine Antiquities,  
Antoniou Kamara 3, Veria, 591 00, Greece.  
Tel/Fax (+30) 331 65576 Email theolkal@otenet.gr

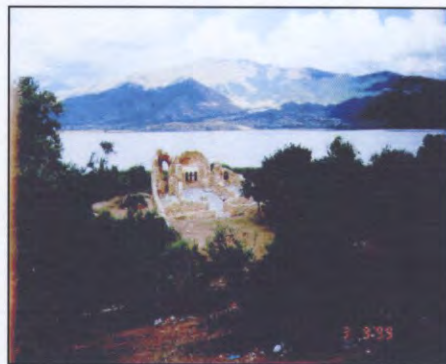
**Figure 2. St. Achillius.**

The church, preserved in ruins, is exceptionally large. (Fig. 2) It was fully excavated in 1960s by prof. N. Moutsopoulos. All ground plan has been saved and permits understanding the whole arrangement and typology of the building, its function and its construction. The coins found during the excavation in Basilica prove that the church functioned until the middle of the 15<sup>th</sup> c.

All masonry and especially mortars suffered considerable deterioration as the result of century's exposure to the weather conditions. Slight inclination from vertical was noted to the piers of the north – east part. The preserved parts of the floor were badly deformed. Furthermore, occasional interventions with excessive use of cement caused either further deterioration of structural materials or aesthetic problems.

The conservation of the existing structure contained extended pointing of joints at a depth of approximately 5cm to prevent further deterioration and to protect the original mortar behind it. All concrete or mortar caps on top of the walls, built to protect them from rainwater, were removed, as they were not effective and, they caused deterioration on the masonry below. A sacrifice layer of stone masonry was built instead, where waterproof material was added to its mortar, to increase its resistance to water penetration.

Limited rebuilding for structural reasons was carried out in the northern row of pillars, while in 1989 the two doorway arches between the diaconicon and the nave had also been rebuilt for static reasons. At the east part of the northern row of pillars two pillars have been preserved almost in full height and between them one more at a lower height. The north part of the sanctuary has also been preserved at a large height, while all connecting arches had been destroyed. In 1899 this part of the monument was still standing complete, with all arches in place, as two photographs taken by Miljukov at that time show. In the mid - sixties, photographs taken during the excavation works show that on one pier the genesis of the upper arches was still in place. During the recent restoration, traces of lower row of arches were only saved to the two taller piers. Those traces, together with the old photographs, gave enough information for a safe reconstruction of the lower row of arches. A concrete slab, constructed in the sixties for stability reasons, was removed and three arches were rebuilt.

Finally the floor has been repaired in parts by removing the stone slabs, stiffening the soil underneath at a horizontal level and repositioning the slabs at the same place. The destroyed parts were completed with sand - gravel.

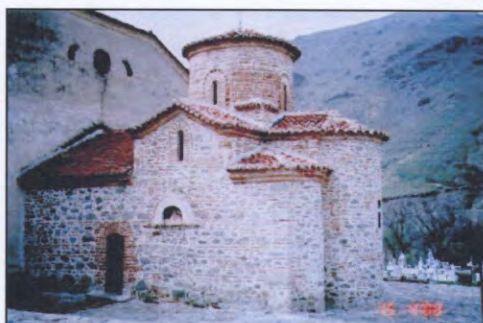
Figure 3. St. Germanos.

The church was preserved in pretty good condition. Rising damp was one of the problems to be solved as well as occasional cracks on masonry. The aim of the project was to face the problems above and to improve the image of the monument by intervening to it and to its direct environment.

The condition of masonry was fairly good. Mortar was deteriorated, mainly on the walls of the narthex. Pointing was confined only to the deteriorated areas, while later interventions were preserved and conserved. The flagstones of the floor were fixed with mortar. Cleaning and consolidation of frescoes has also started and is still in progress.

During the conservation works all plaster of the facades was removed. (Fig. 3) The original masonry brought to light has tile decoration and is reminiscent of the monuments of the same period in the area and especially in Kastoria. All initial decorative strips at the top of the walls, underneath the roof, were destroyed and replaced by later and simpler. Both conches of prothesis and diakonikon were mostly rebuilt, while the height of the external walls and the

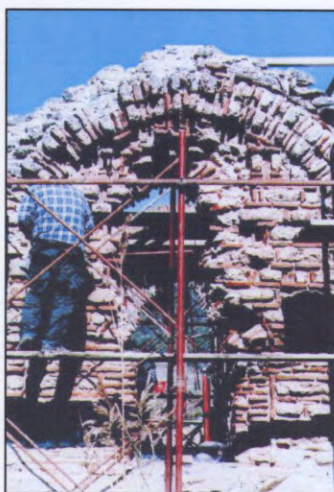
**Fig. 4. St. Nikolas in Pili.**

The monument suffers from its exposure to the weather conditions. Additionally, it gets flooded during winter and spring, due to its neighboring to the lake. This causes salts from rising damp and decay to the foundation.

The conservation project, still in progress, retains the present image of the monument. A photograph of the south façade, dated from 1899, presents the dome and parts of this façade, destroyed today. This picture, together with traces on the wall (Fig. 4), permit a reconstruction of this part of the monument, some of which will be rebuilt, mainly for educational and documentation reasons.

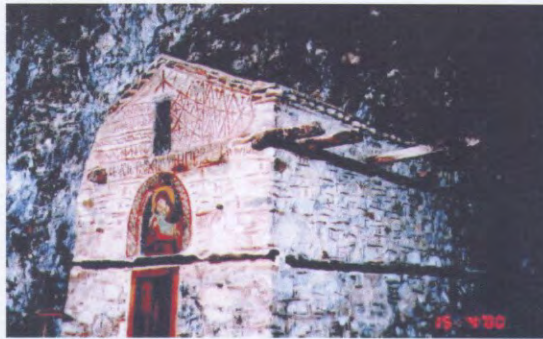
Fig. 5. Hermitage of Panayia Eleousa.

These are the oldest surviving hermitages in Large Prespa, built in a cavity of the rock, both approached by boat. They preserve their small church, while ruins of cells are spread around. The churches are single-cell structures, barrel-vaulted. Panayia Eleousa keeps its initial form (fig. 5). Metamorfosis was enlarged by moving back the western and northern walls. A timber roof covered the addition. The southeastern section of the church is thus the only surviving part of the original building, with traces of wall painting still visible on the vault.

Limited repair works were carried out to Panayia Eleousa, especially to consolidate the southwest part of foundation, while more extended were the works to Metamorfosi, including interventions to masonry and roof. Furthermore, the cells were repaired and the environmental space was improved. Frescoes were partly cleaned and consolidated and archaeological research was made to Metamorfosis to reveal the initial size and form of it.
