RESTORATION WORK ON BYZANTINE AND POST-BYZANTINE MONUMENTS IN THE PRESPA AREA - GREECE

Kleopatra Theologidou

Ministry of Culture, 11th Ephorate of Byzantine Antiquities,
Antoniou Kamara 3, Veria, 591 00, Greece.
Tel/Fax (+30) 331 65576 Email theolkal@otenet.gr

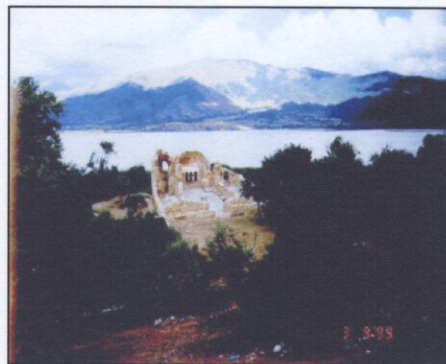
Figure 2. St. Achillius.

The church, preserved in ruins, is exceptionally large. (Fig. 2) It was fully excavated in 1960s by prof. N. Moutsopoulos. All ground plan has been saved and permits understanding the whole arrangement and typology of the building, its function and its construction. The coins found during the excavation in Basilica prove that the church functioned until the middle of the 15th c.

All masonry and especially mortars suffered considerable deterioration as the result of century's exposure to the weather conditions. Slight inclination from vertical was noted to the piers of the north – east part. The preserved parts of the floor were badly deformed. Furthermore, occasional interventions with excessive use of cement caused either further deterioration of structural materials or aesthetic problems.

The conservation of the existing structure contained extended pointing of joints at a depth of approximately 5cm to prevent further deterioration and to protect the original mortar behind it. All concrete or mortar caps on top of the walls, built to protect them from rainwater, were removed, as they were not effective and, they caused deterioration on the masonry below. A sacrifice layer of stone masonry was built instead, where waterproof material was added to its mortar, to increase its resistance to water penetration.

Limited rebuilding for structural reasons was carried out in the northern row of pillars, while in 1989 the two doorway arches between the diaconicon and the nave had also been rebuilt for static reasons. At the east part of the northern row of pillars two pillars have been preserved almost in full height and between them one more at a lower height. The north part of the sanctuary has also been preserved at a large height, while all connecting arches had been destroyed. In 1899 this part of the monument was still standing complete, with all arches in place, as two photographs taken by Miljukov at that time show. In the mid - sixties, photographs taken during the excavation works show that on one pier the genesis of the upper arches was still in place. During the recent restoration, traces of lower row of arches were only saved to the two taller piers. Those traces, together with the old photographs, gave enough information for a safe reconstruction of the lower row of arches. A concrete slab, constructed in the sixties for stability reasons, was removed and three arches were rebuilt.

Finally the floor has been repaired in parts by removing the stone slabs, stiffening the soil underneath at a horizontal level and repositioning the slabs at the same place. The destroyed parts were completed with sand - gravel.

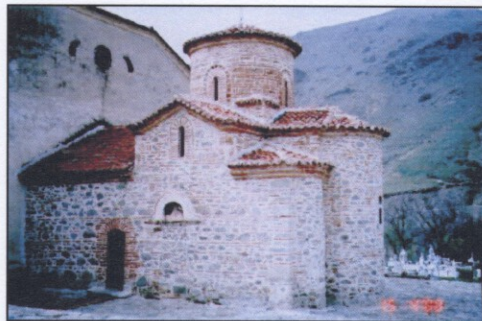
Figure 3. St. Germanos.

The church was preserved in pretty good condition. Rising damp was one of the problems to be solved as well as occasional cracks on masonry. The aim of the project was to face the problems above and to improve the image of the monument by intervening to it and to its direct environment.

During the conservation works all plaster of the facades was removed. (Fig. 3) The original masonry brought to light has tile decoration and is reminiscent of the monuments of the same period in the area and especially in Kastoria. All initial decorative strips at the top of the walls, underneath the roof, were destroyed and replaced by later and simpler. Both conches of prothesis and diakonikon were mostly rebuilt, while the height of the external walls and the

The condition of masonry was fairly good. Mortar was deteriorated, mainly on the walls of the narthex. Pointing was confined only to the deteriorated areas, while later interventions were preserved and conserved. The flagstones of the floor were fixed with mortar. Cleaning and consolidation of frescoes has also started and is still in progress.

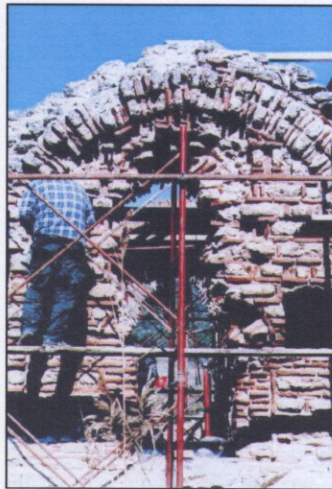
Fig. 4. St. Nikolas in Pili.

The monument suffers from its exposure to the weather conditions. Additionally, it gets flooded during winter and spring, due to its neighboring to the lake. This causes salts from rising dump and decay to the foundation.

The conservation project, still in progress, retains the present image of the monument. A photograph of the south façade, dated from 1899, presents the dome and parts of this façade, destroyed today. This picture, together with traces on the wall (Fig. 4), permit a reconstruction of this part of the monument, some of which will be rebuilt, mainly for educational and documentation reasons.

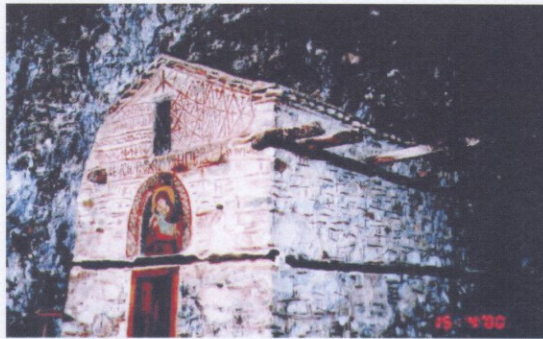
Fig. 5. Hermitage of Panayia Eleousa.

These are the oldest surviving hermitages in Large Prespa, built in a cavity of the rock, both approached by boat. They preserve their small church, while ruins of cells are spread around. The churches are single-cell structures, barrel-vaulted. Panayia Eleousa keeps its initial form (fig. 5). Metamorfofis was enlarged by moving back the western and northern walls. A timber roof covered the addition. The southeastern section of the church is thus the only surviving part of the original building, with traces of wall painting still visible on the vault.

Limited repair works were carried out to Panayia Eleousa, especially to consolidate the southwest part of foundation, while more extended were the works to Metamorfofi, including interventions to masonry and roof. Furthermore, the cells were repaired and the environmental space was improved. Frescoes were partly cleaned and consolidated and archaeological research was made to Metamorfofis to reveal the initial size and form of it.
