The Restoration of Agia Kiriaki in Grevena, Greece

K. Theologidou

*Ministry of Culture, 11th Ephory of Byzantine
Monuments, Greece*

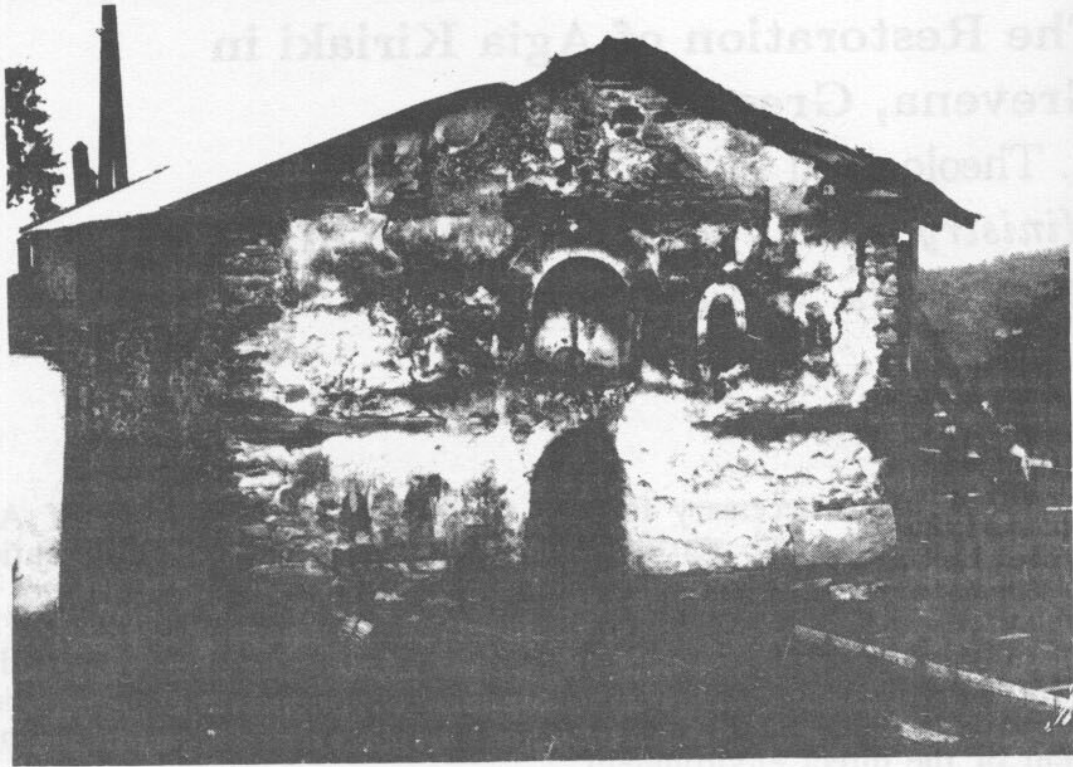
fig. 1 The church of Ag. Kiriaki in 1989 before the restoration works. Western facade.

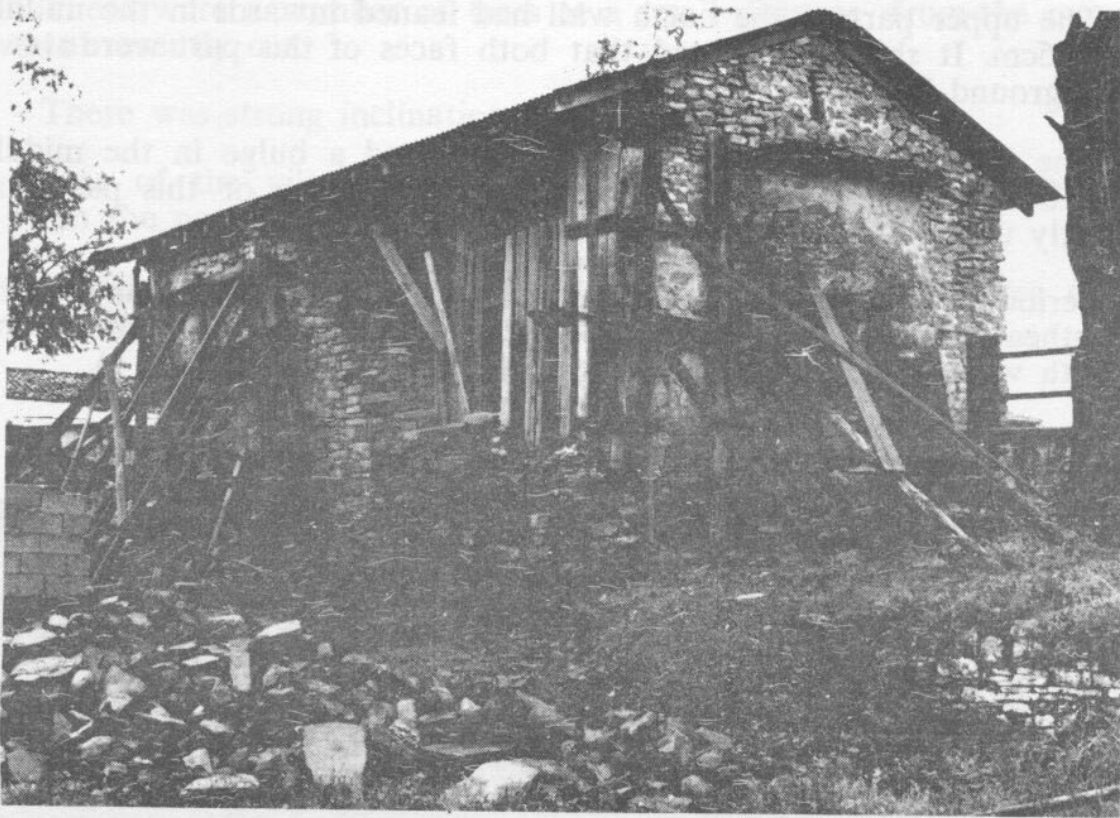
- The east part of the south wall had collapsed at a length of approximately 4m (fig. 2). This part of the wall had collapsed once again in the past and had been rebuilt of stone and mud mortar.
- The rest of the south wall had strongly leaned outwards (fig. 3). This inclination measured 43cm, while the height of the wall was 400cm and the depth 75cm.

fig .2 South east corner.

Together with the research work on site and in the office, these inspections proved that the main reason for the collapse of the east part of the south wall was its foundation partly on the soil and partly on the grave. A further reason was the fact that the rest of this wall was founded on the ground, while the east wall on the foundation of an older building. This conclusion is supported by the fact that the collapsed part of the wall was the only one which had created serious problems in the past.

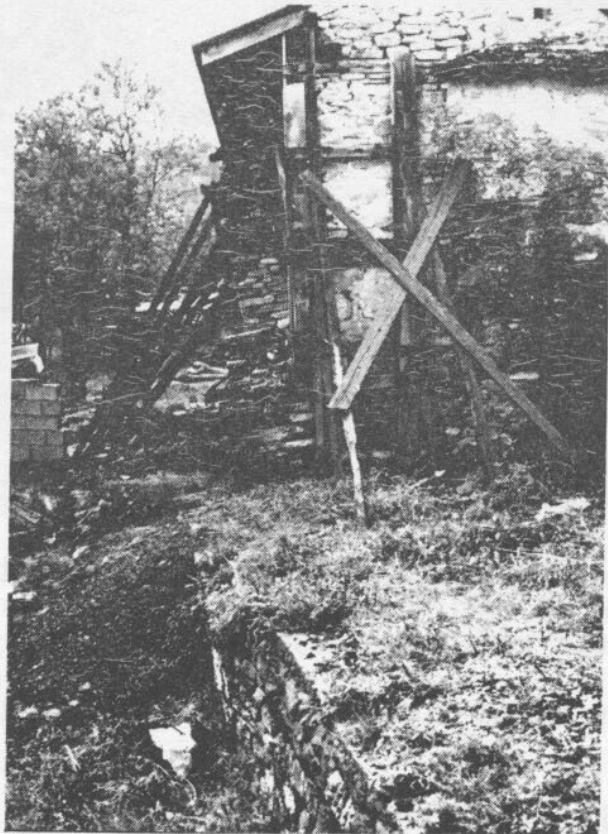
fig. 3 The outward leaning south wall

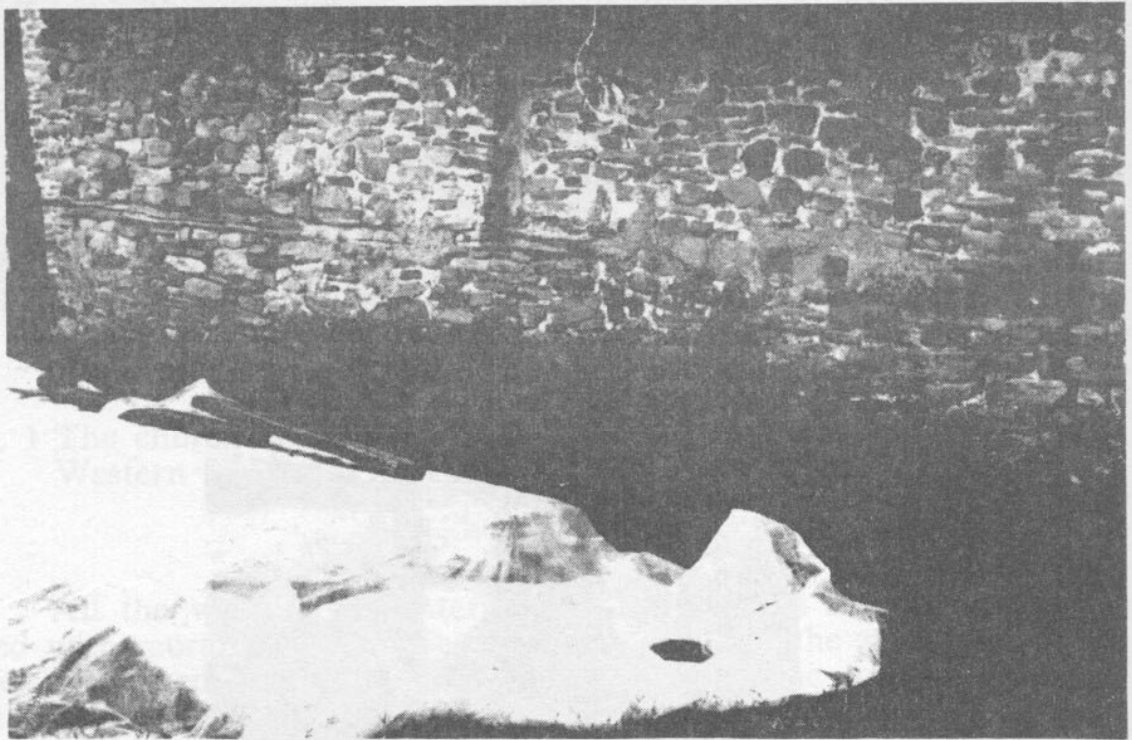
- The upper part of the north wall had leaned inwards in the middle by 15cm. It should be noted that both faces of this part were above the ground level.
- The internal face of the north wall formed a bulge in the middle of its lower part. The corresponding external face of this part was partly under the ground level.
- Serious cracks appeared on the three corners of the monument (the southeast corner had collapsed). Among them, those on the north and south wall were assessed as being in a critical condition (fig. 4).

fig. 4 Northern facade. Destroyed tie beams, moisture and cracks are some of the problems.

- Timber tie beams were partly destroyed, especially at their joints.
- The mortar was in fair condition.
- Excessive moisture appeared on the lower parts of the north and east wall.

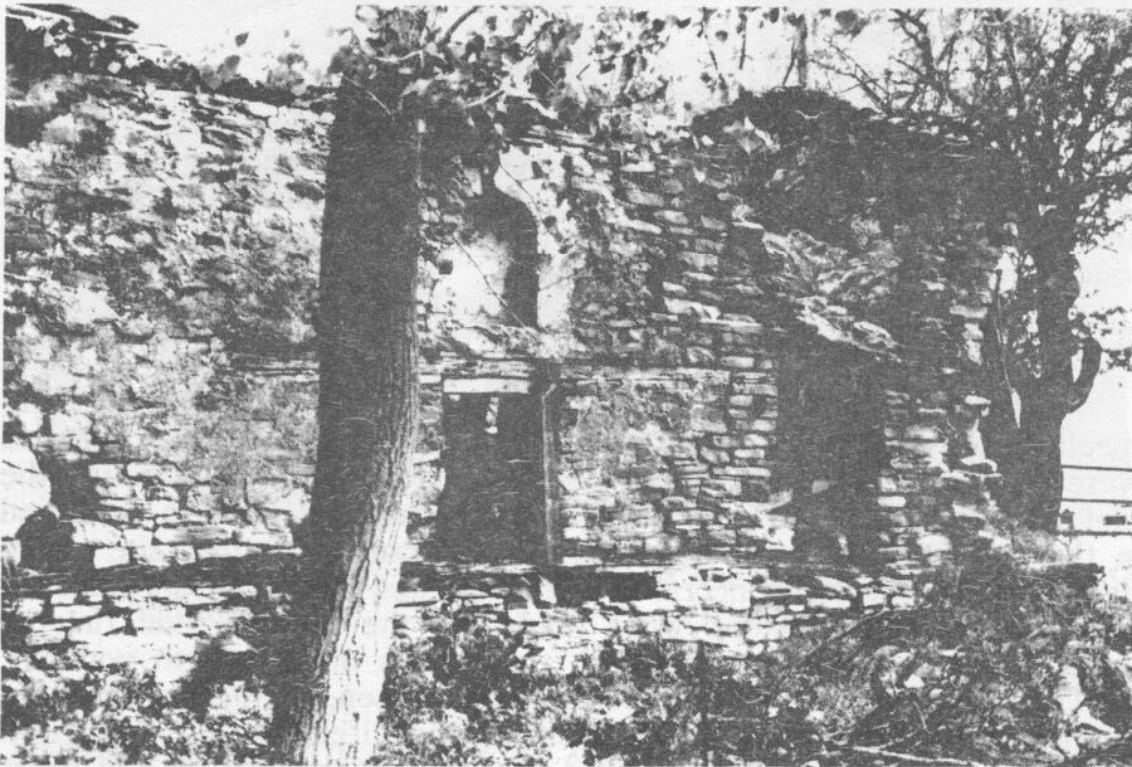
A research was also undertaken into the archives of the 11th Ephory of Byzantine Monuments, so as the history and the problems of the monument to be further investigated. From this research, together with photographs dated from the same period (fig. 5), a fairly complete picture of the condition of the monument in the last two decades was obtained.

fig. 5 The south wall in 1981. The rebuild part of the east end can be distinguished, as well as the trees very close to the monument.

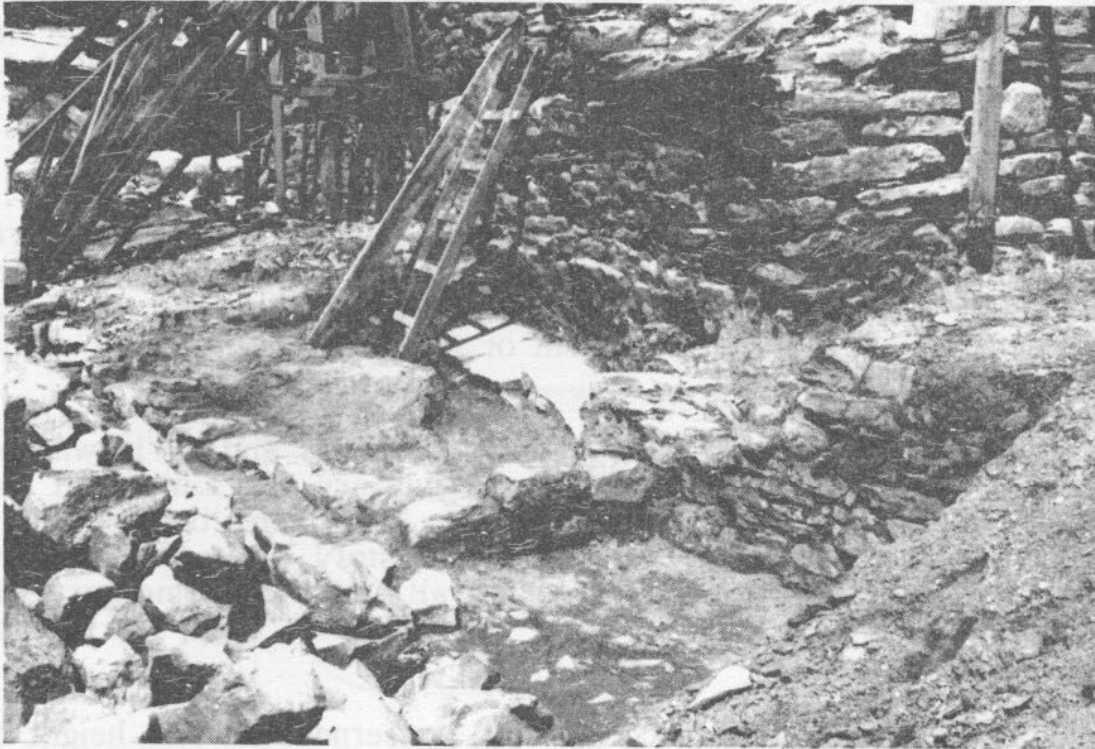
- The foundation of the collapsed part of the south wall lay partly on the ground and partly on a grave. Between the foundation and the grave there was a layer of soil, 30cm thick.

- At a distance of 1,5m from the south wall, the foundation of the south wall of an older building was found. The east wall of this building continued just under the east wall of the church. The above grave lay within the perimeter of this building. Further excavation showed that the surrounding area used to be a cemetery. Therefore, though the excavations have not yet been completed it is presumed that the older building was a church as well.

fig. 6 South east corner. The grave and the foundations of an older building.

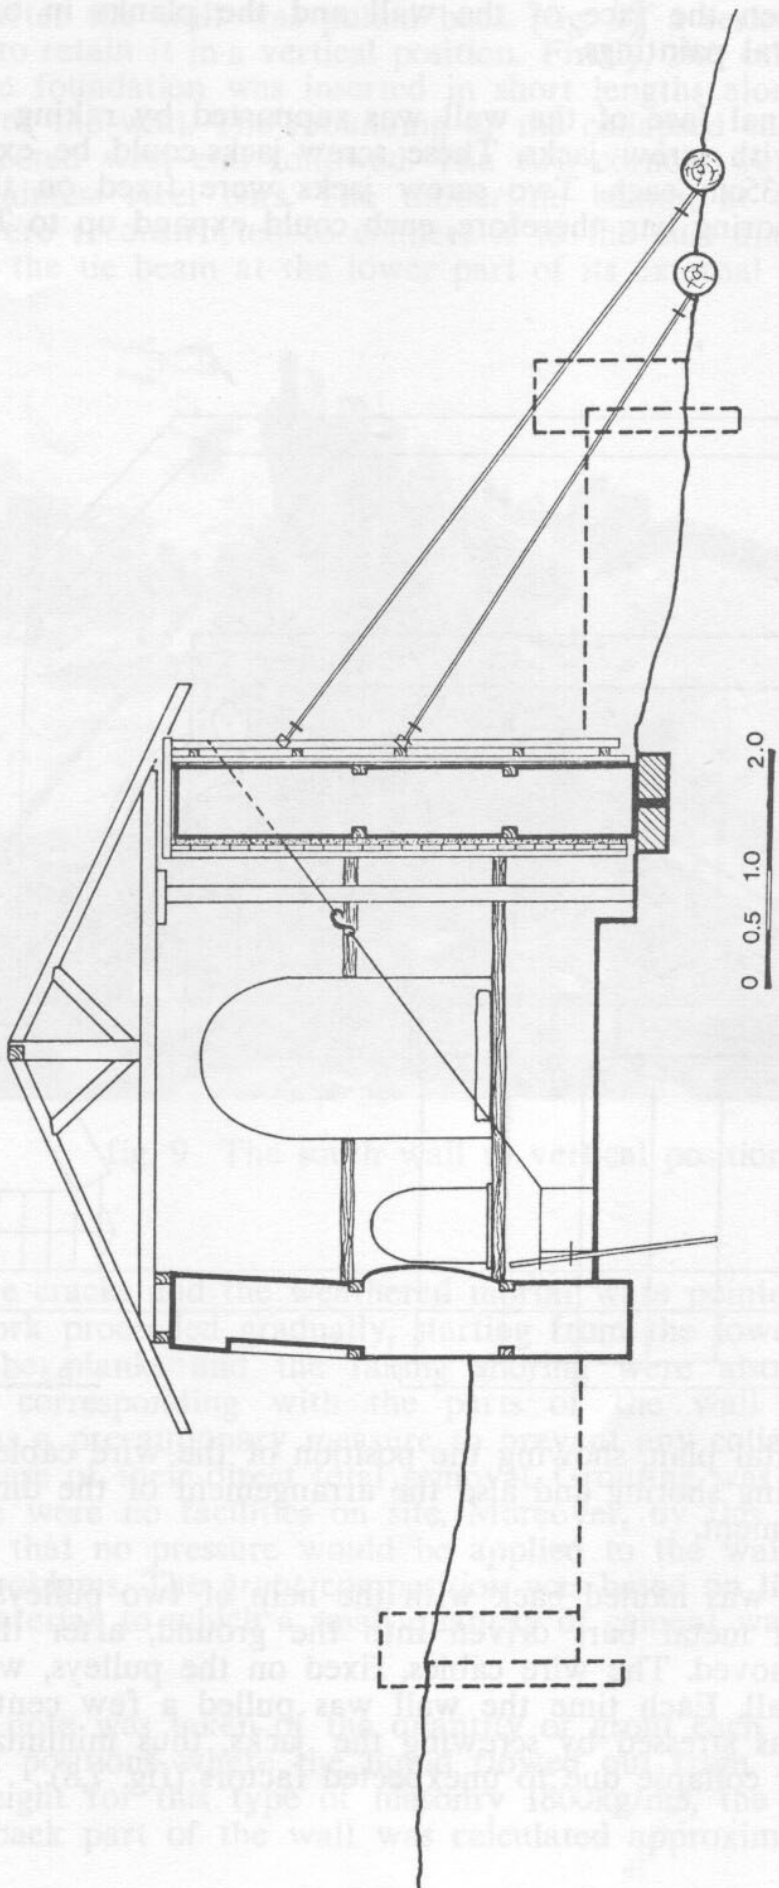
fig. 7 Section showing the south wall to the vertical, the concrete foundation, the shoring and the wire cables. The dotted line shows the arranged level and the retaining walls.

The wall was hauled back with the help of two pulleys, which were fixed on metal bars driven into the ground, after the floor slabs were removed. The wire cables, fixed on the pulleys, were embracing the wall. Each time the wall was pulled a few centimeters, the shoring was stressed by screwing the jacks, thus minimizing the possibilities for collapse due to unexpected factors (fig. 7,8).

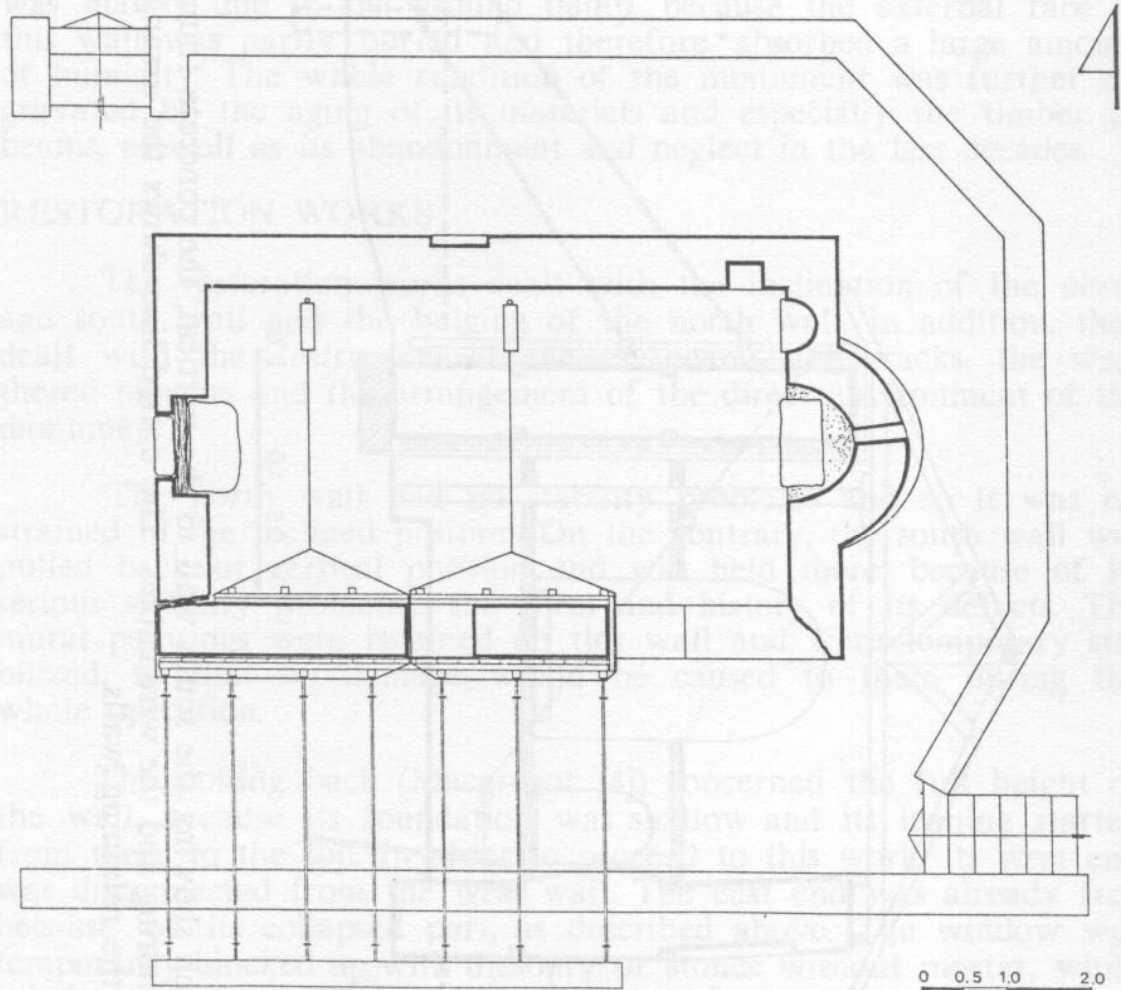
fig. 8 Horizontal plan, showing the position of the wire cables and the raking shoring and also the arrangement of the direct environment.

The ground was lowered to the north in order to be kept approximately at the same level around the monument. A retaining wall was constructed by concrete around the three facades of the monument to support the soil. The top of these walls and their visible face were built of stone masonry (fig. 8).

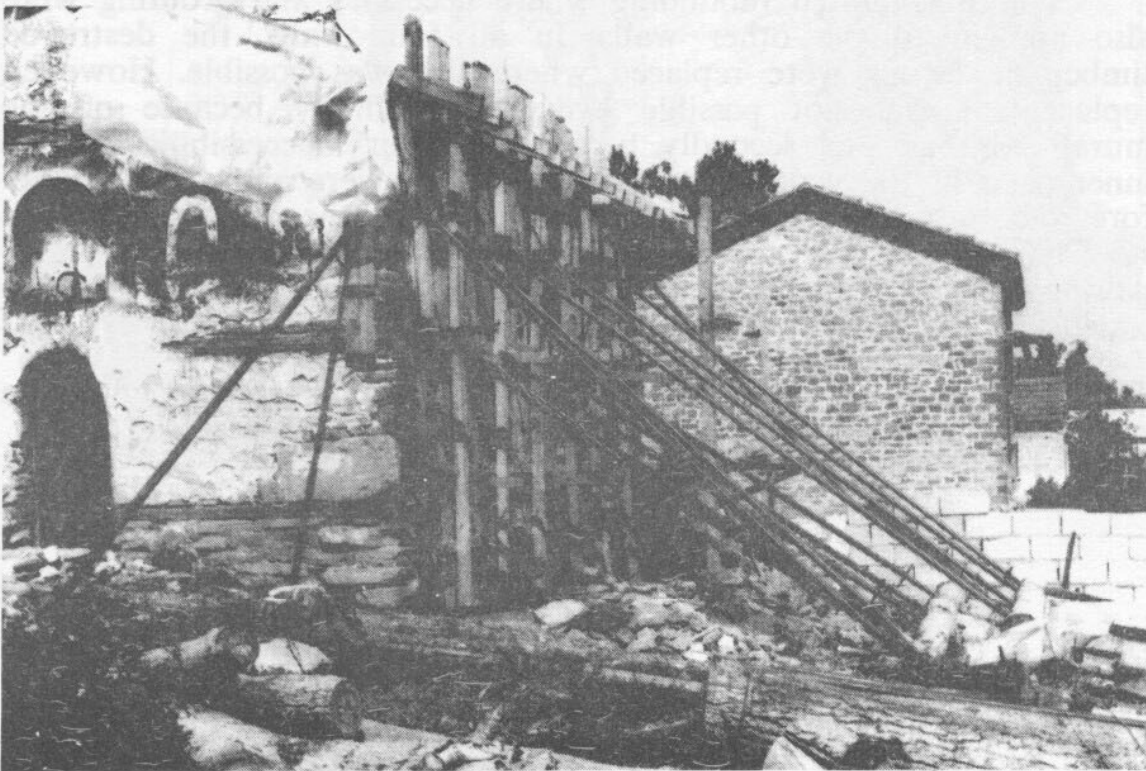
fig. 9 The south wall to vertical position.

After the wall was pulled back (fig. 9), a series of works followed to retain it in a vertical position. Firstly, the other half of the concrete foundation was inserted in short lengths along the external facade of the wall. The rebuilding of the collapsed east part and the disconnected west end followed. The two corners were strengthened with stainless steel bars. The timber tie beams, at the top of the wall, were reconstructed to connect it to the east and west wall, as well as the tie beam at the lower part of its external face.

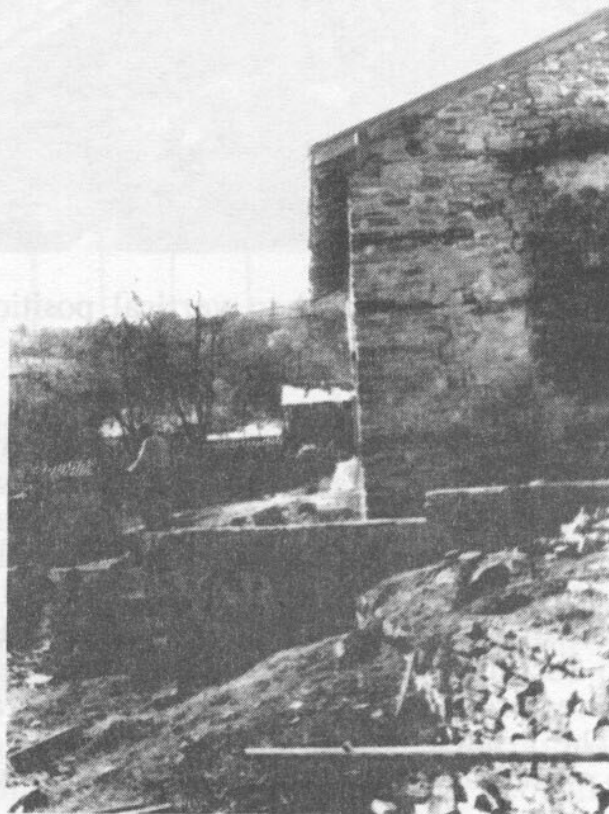
fig. 10 South east corner after the restoration works. A comparison to figure 3 shows the position of the south wall before and after the works.

Pointing, limited rebuilding where necessary and grouting were also applied to the other walls. In all four walls, the destroyed timber tie beams were replaced where this was possible. However, replacement was not possible everywhere, firstly because of the mural paintings and secondly because of their inaccessibility in the inner parts of the walls, where some of them were embedded. Therefore, the four corners of the walls were strengthened with stainless steel bars, positioned horizontally, at different heights. The above repairing works were applied to the north wall as well, and were assessed adequate for its consolidation (fig. 10,11).

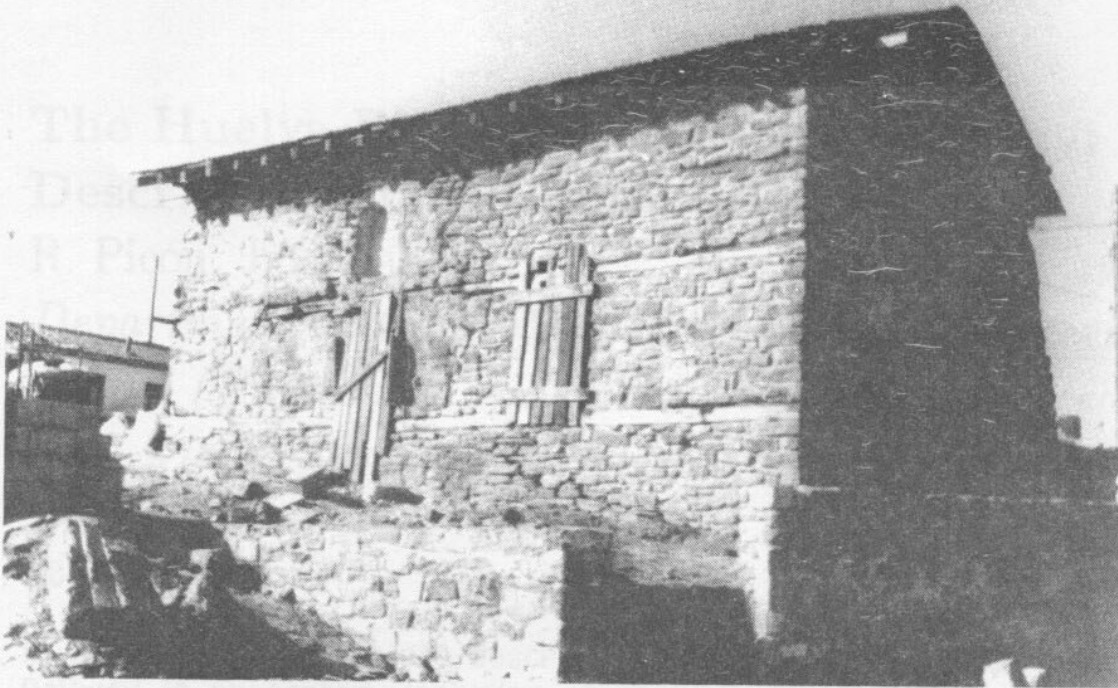
fig. 11 The church after the restoration works.
