FORTMED

Restoration and use of the early medieval fortifications in the east Mediterranean countries

THE CASTLE OF SERVIA. HISTORICAL DOCUMENTATION, ARCHITECTURAL DESCRIPTION, PATHOLOGY, PROPOSED REPAIR WORKS

KLEOPATRA THEOLOGIDOU

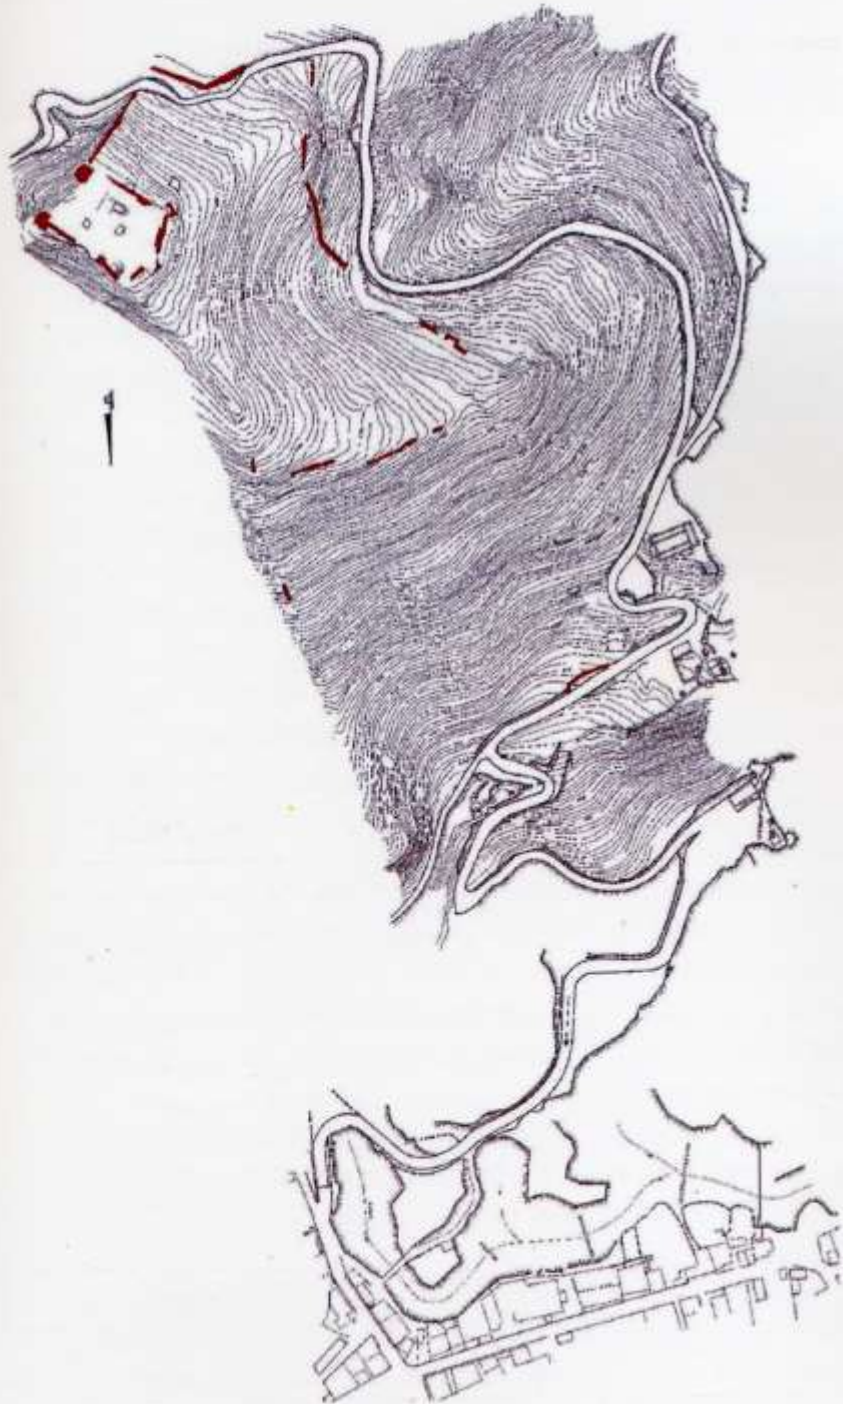
Plan I: The castle of Servia. Ground plan.

According to the preserved ruins and written evidence, the castle was divided into three parts, the outer enclosure, the inner enclosure and the Acropolis (plan I).

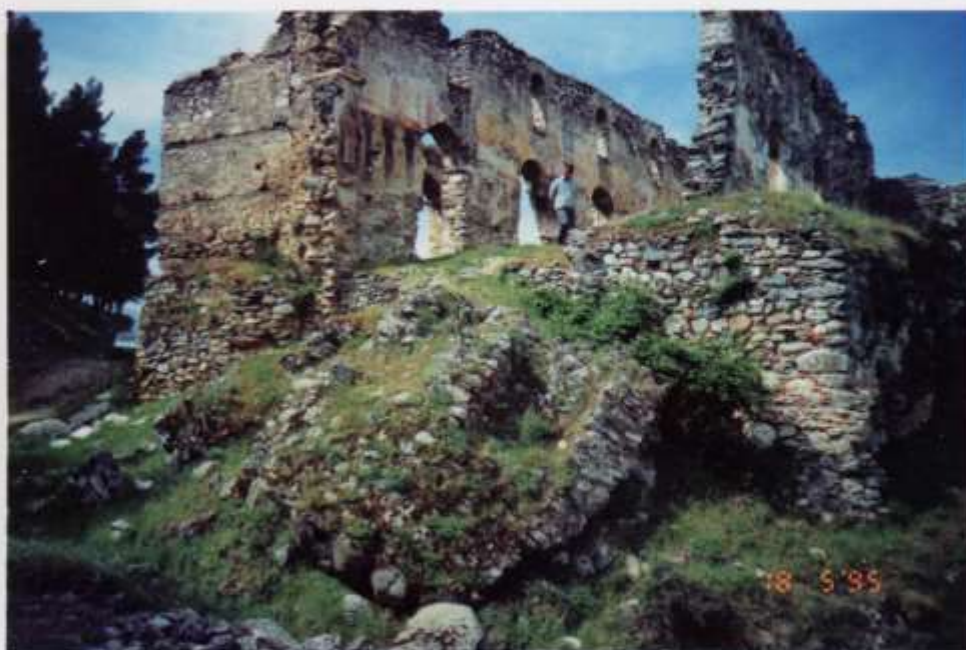
figure 1: Basilica of Catechized, or St. Demetrius (11th century).

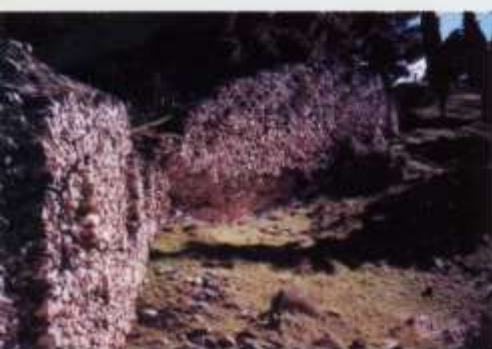
figure 2: Inner Enclosure.

The military lived in the inner enclosure. This enclosure is better preserved (figure 2). Most of its perimeter is visible and is saved at a relatively large height. It has a polygonal form and it was the second line of defense and the shelter for the population, in case of capture of the outer part. At the intermediate wall, two rectangular towers are distinguished. Though this part of the castle is better preserved, traces of entrance have not been revealed so far. Only the traces of a small secondary entrance on the southwest part are visible (figures 2, 4), which later on was transformed to a window and even later was filled up. This entrance, very close to the Acropolis, was on an unapproachable location, due to the strong inclination of the ground. The inner enclosure was thinly inhabited. The ruins of buildings in this area are sparse. Traces of a cistern are visible, which preserve hydraulic plaster on the internal façade of its masonry.

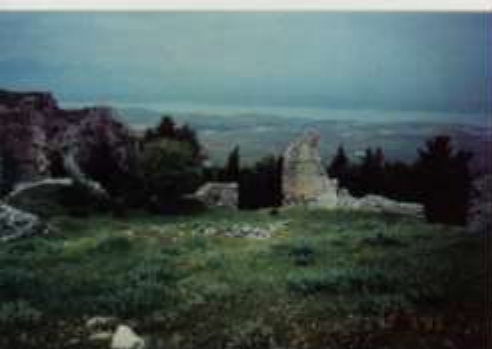
figure 3: Acropolis.

The Acropolis was the last line of defense (figure 3). There existed the house of the sovereign and military buildings. Some remains of them are still visible. The Acropolis is the better preserved part of the castle. Its perimeter is saved at a large height. It had a quadrilateral form. Three towers are preserved at a large height. The two of them are rectangular and very much alike (figures 12, 17, 18, 22, 23, 24), while the third one, at the southwest corner, is polygonal and massive (figures 4, 19, 20). The rectangular towers were three-storey buildings with timber floors and probably roofed with a flat timber terrace, which was accessible, as battlements, partly preserved, indicate. Traces of the timber beams are inscripted on the masonry (figures 23, 24). Narrow windows with brick arches existed on the upper floors. These towers are the only structures of the fortification, where brick decoration is observed (figure 5).

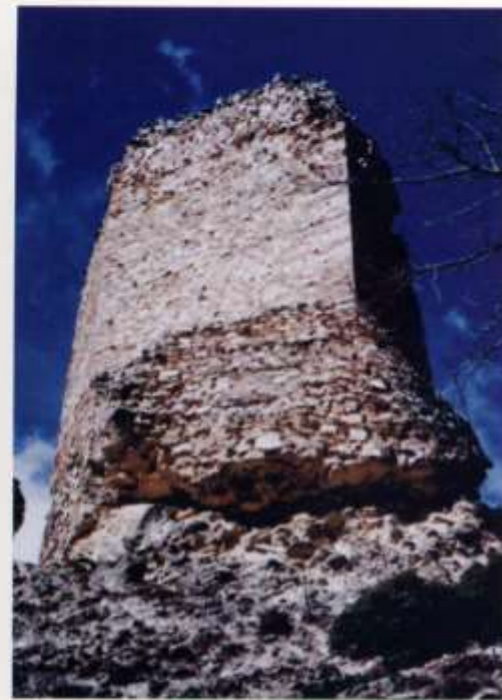
figure 4: The massive tower of Acropolis. The lower part belongs to the first phase and the upper to the second.

1. The polygonal massive tower of Acropolis, where two phases are noticed, one at its lower parts and the other at the upper (figure 4, 19, 20, plan 6). The phase at the base is obviously the earlier one. It appears that initially this tower was a round one, not massive, as shown by its internal face, which continues underneath the later construction (figure 6). It seems that later on, the massive part was constructed on the ruins of the round tower. This massive part has a similar way of structure, with stones and bricks all over, which shows that it has only one phase.

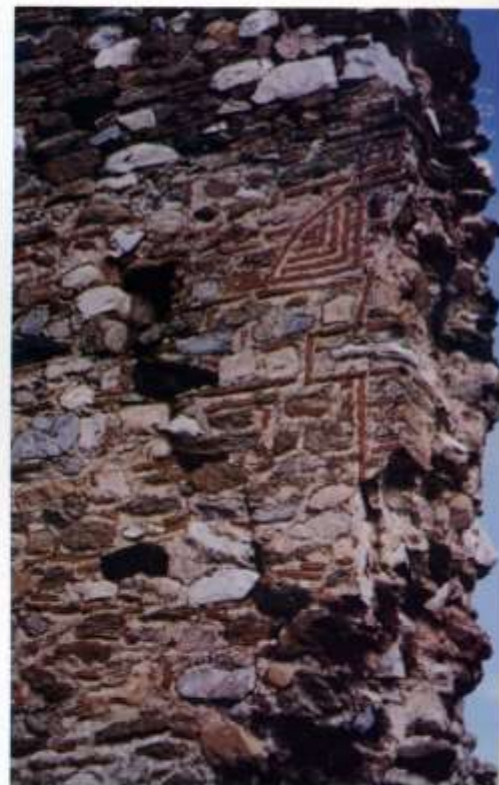
figure 5: Northwest rectangular tower. Detail of brick decoration.

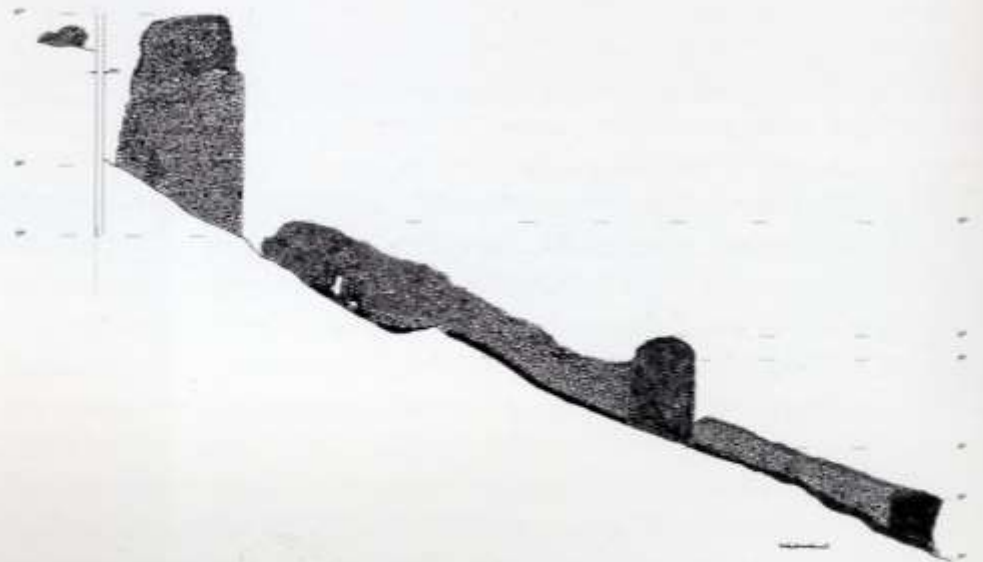
Plan 2: Massive tower of Acropolis and part of the inner enclosure.

The ground plan has been drawn in a scale of 1:100. All façades of the walls, internal and external, have been drawn in a scale of 1:50 (plans 2, 3, 4).

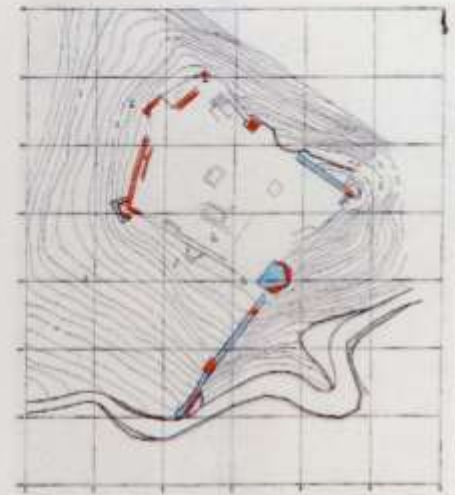
Plan 5: Acropolis. Building phases.

Three building phases are distinguished; the two of them are shown on plan 5. These two phases shown on the plan have been noted due to different building techniques, different mortar composition, as proved by chemical analysis, and in some cases, building joints. The third phase observed is located to the upper parts of the rectangular towers of Acropolis and was localized due to its different building technique. However, because of its unapproachable position it was not easy to get samples for further chemical analysis. The broad dating of these phases was possible because of their position on the structures and comparative work to dated parts of the castle and from written evidence. More specifically, different building phases are observed at:

3. The northeast façade of Acropolis. In the middle of this façade there is a structure, which seems to be a massive tower. Mortars from the core of the masonry have the same composition with the first phase and mortars from the face have the same composition with the second phase (plan 5).

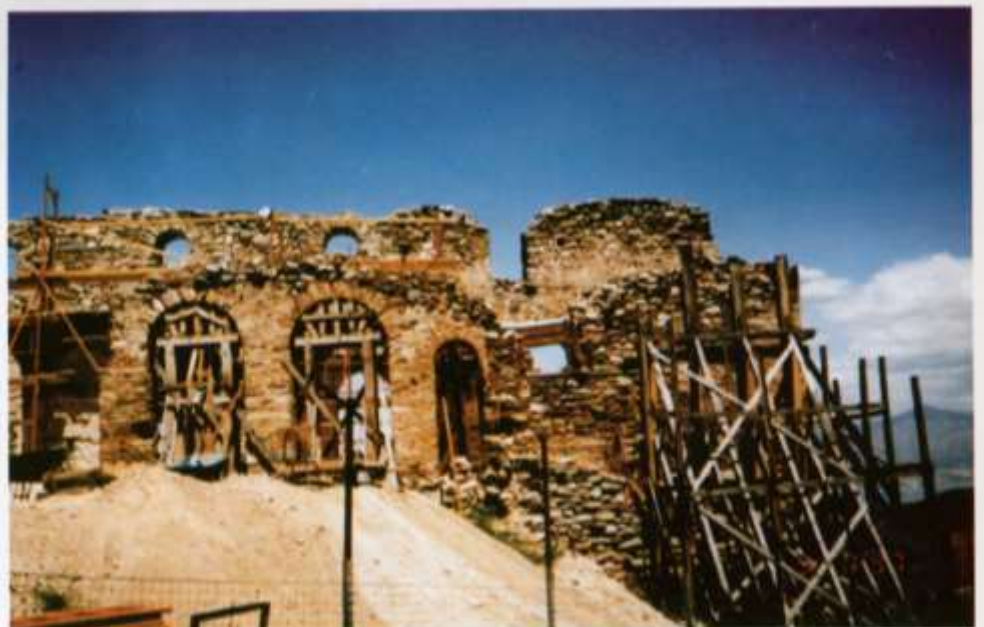
figure 6: Massive tower of Acropolis. The face of the wall of the earlier phase continues under the upper massive structure.

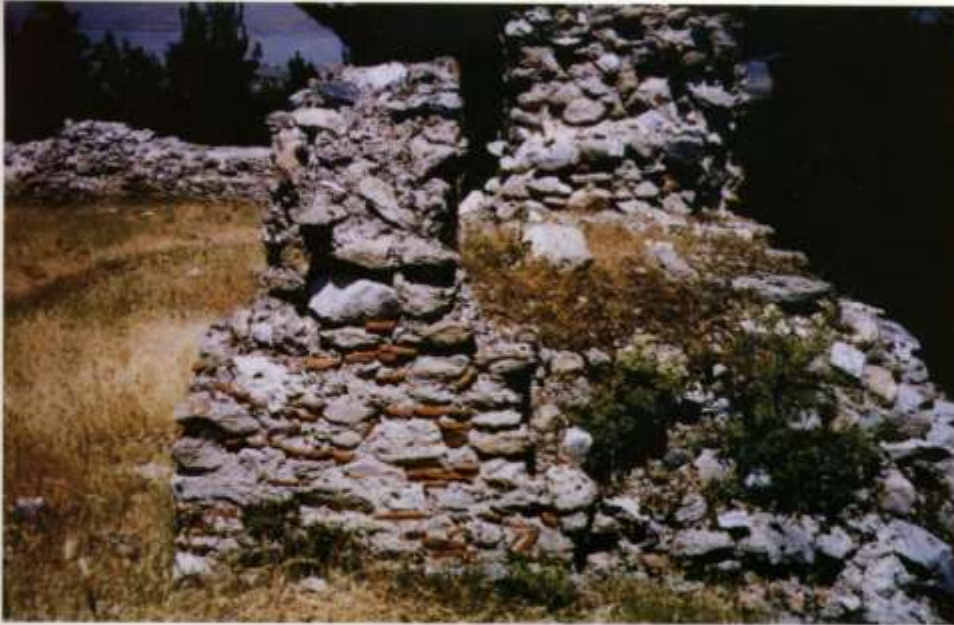
figure 7: Basilica of Catechized. South façade. The arches date from the 14th century.

(second phase of Acropolis and most parts of the inner enclosure) date from the 11th century. The way these parts are built with extended use of bricks positioned to a random way, mainly horizontally, supports this point of view. There have not been found any documents so far to support a theory, concerning the date of the first phase. The third phase was noticed to the upper parts of the two rectangular towers of Acropolis. If we compare the techniques of building to those of the basilica of Catechized, we will find many similarities to this part dating from the 14th century³ (figure 7, 22).

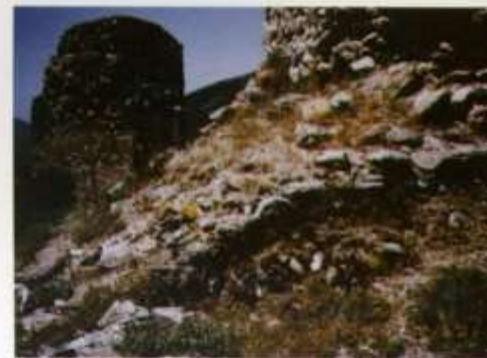
2. The northeast corner of Acropolis. A joint that separates the masonry in two parts, parallel to its thickness, prove two different phases at this position, as well. It seems that at this part the thickness of the walls was increased by building a second wall in contact with the internal façade of the existing one (figure 8). This is proved by the observation that the internal façade of the outer part of the wall, which was revealed due to its division from the inner wall, is formed as a visible face with stones and horizontal bricks. On the contrary, the external façade of the inner wall is flat due to its contact with the external wall, without however having a formed face. Moreover, traces on the ground prove the position of a building here, which could be a tower (figure 9).

figure 8: Acropolis. Northeast corner. The two phases are easily distinguished.

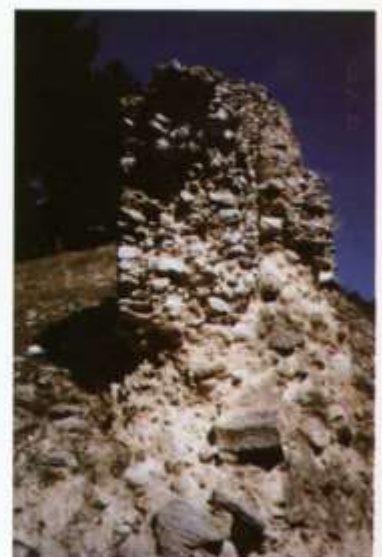
figure 9: Acropolis. North corner. Traces of a building, possibly a tower.

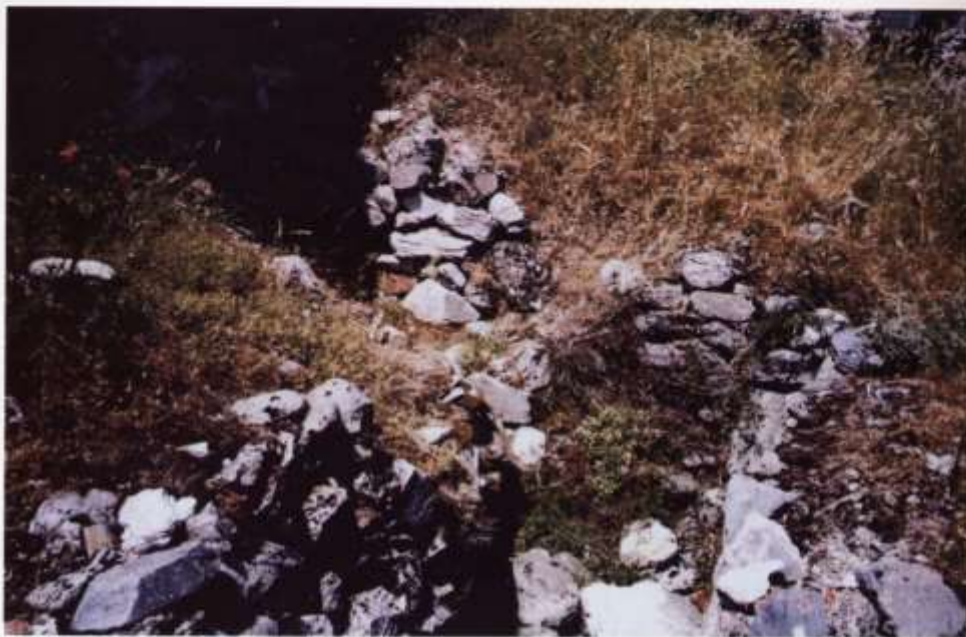
6. Southeast part - inner enclosure. It appears that the outer face of the walls in this area, most of which has collapsed, belong to the first phase and the inner face, better preserved, belongs to the second. A joint on the demolished edge of these walls between its outer and inner face support this argument (figures 10, 25).

figure 10: Inner enclosure. Southeast part. The two different phases. The inner part was probably constructed later to increase the thickness of the wall.

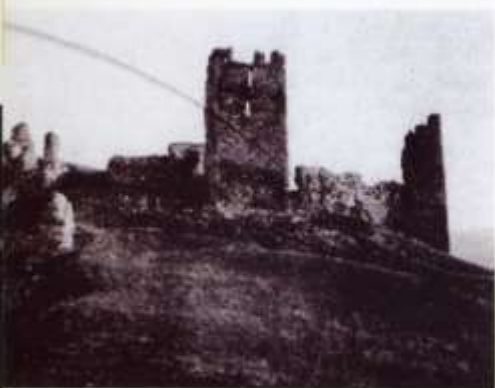
figure 11: Traces of wall, parallel to the west part of Acropolis.

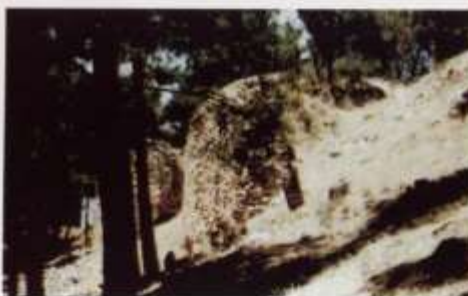
All these factors above are also the main reasons for the decay observed on the remaining parts of the castle. In addition, different types of vegetation, grown on the masonry and humidity aggravate the existing condition.

figure 13: Trees close to the walls of the inner enclosure.

1. Repointing, rebuilding and grouting of cracks.
2. Joint pointing in depth, where they are deeply decayed.
3. Rebuilding of demolished masonry at the lower parts of the walls, to stabilize the superstructure.
4. Rebuilding of loose masonry.
5. Limited grouting to fill voids, where necessary.
6. Replacement of rotten timber ties.
7. Building a sacrificial stone layer on top of the walls to prevent rainwater from penetrating the masonry.

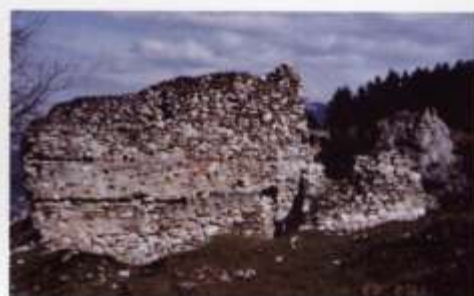
figure 14: Acropolis. Northwest part of the wall. Internal façade. Loose masonry at the upper part and rotten tie beams.

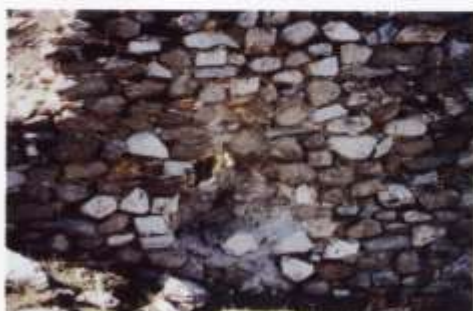
figure 15: Acropolis. West part of the walls. Internal façade. Demolished masonry at the lower part.

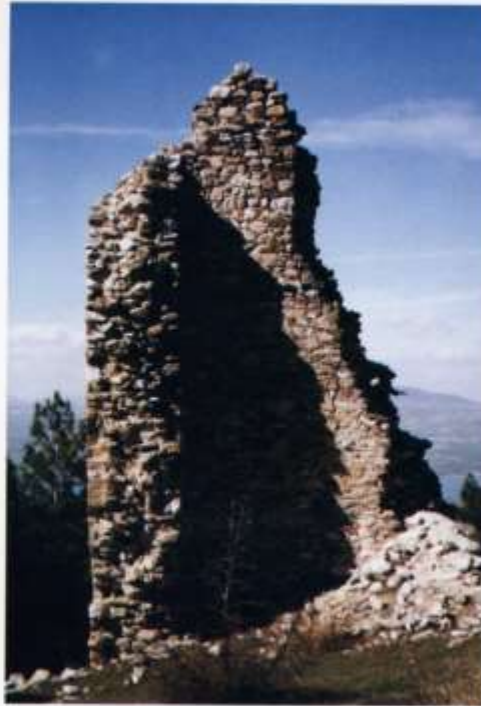
figure 17: Acropolis Northwest tower. After the earthquake in 1995.

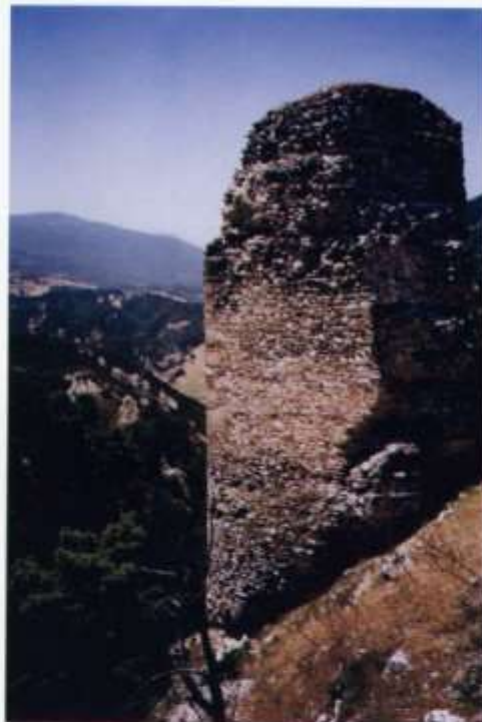
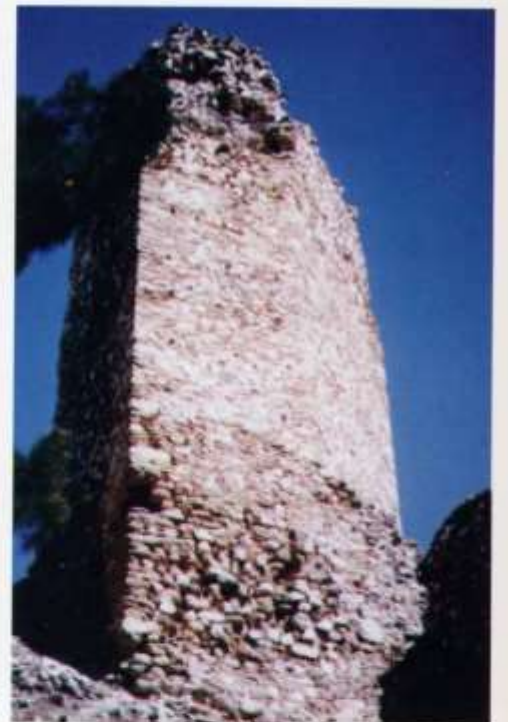
figure 19, 20: Acropolis. Massive tower. Ground problems and demolished masonry at the lower and upper parts.

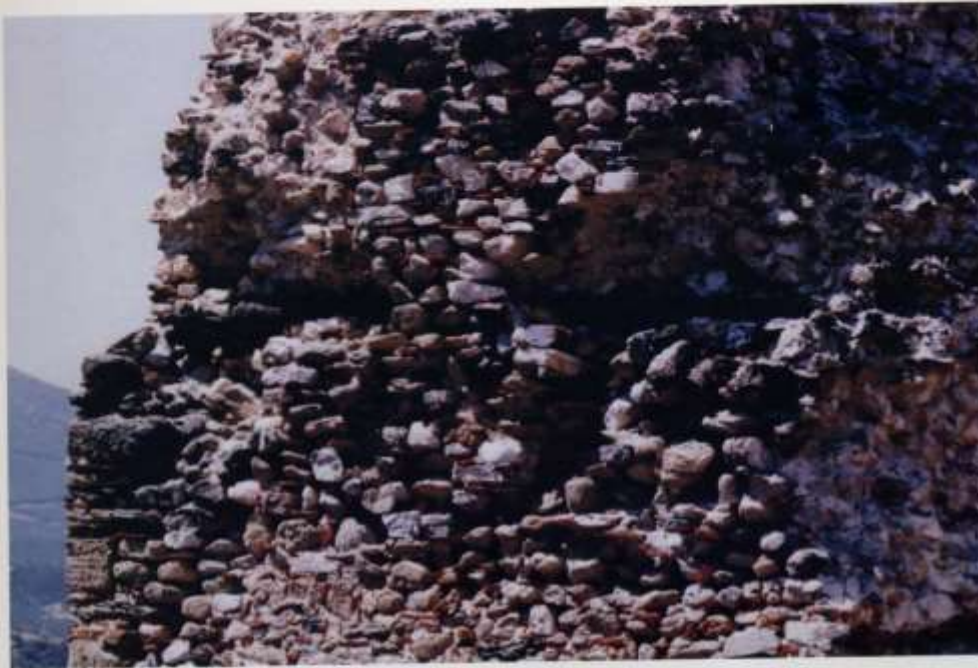
figure 21: Acropolis. Massive tower. Decayed joints and timber ties, behind the face of the wall.

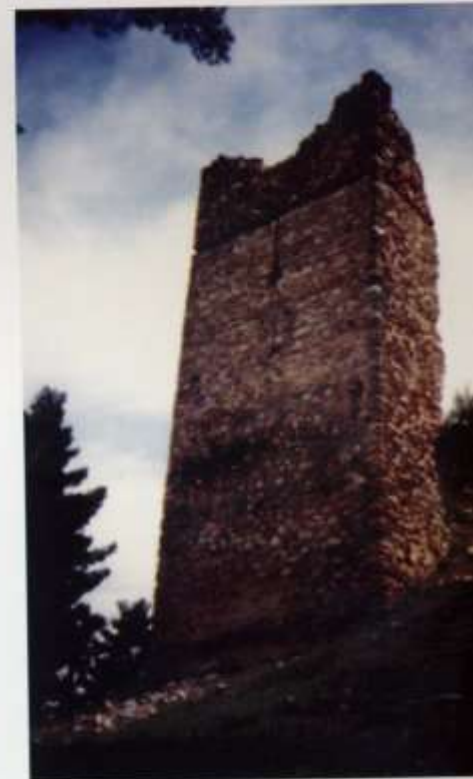
5. West tower. At this tower three faces were recorded. According to chemical analysis, the lower parts of this tower belong to the earlier phase, the same to the lower parts of the massive tower while a little higher, some parts belong to the second phase. The upper parts belong to the third phase (figure 22).

figure 22: Acropolis. West tower damaged by the earthquake in 1995.

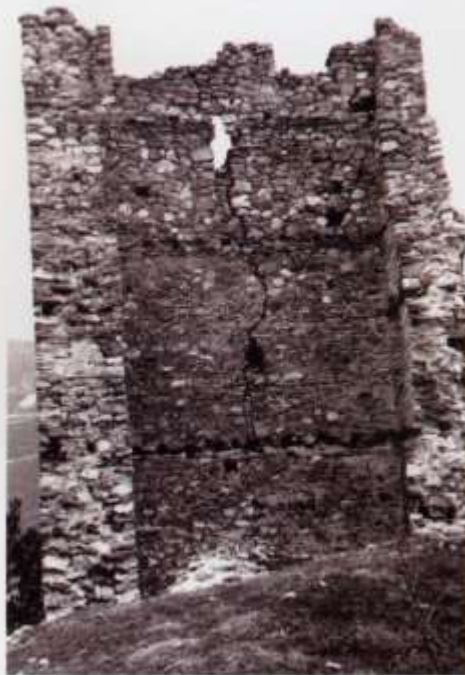
The castle suffers from extended demolition due to its abandonment for centuries. Whole parts are completely missing, especially those of the outer enclosure. Moreover, all the upper parts of towers and walls have also collapsed, with only one exception, the west tower of Acropolis, which still preserves some traces of the battlements (figures 23, 24).

figure 23: West tower in 1997. The battlements on top are distinguished.

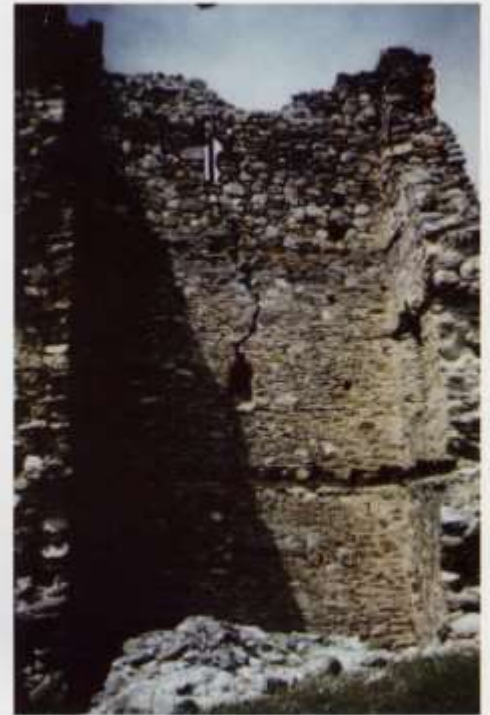
figure 24: West tower in 1995. The rate of decay is obvious.

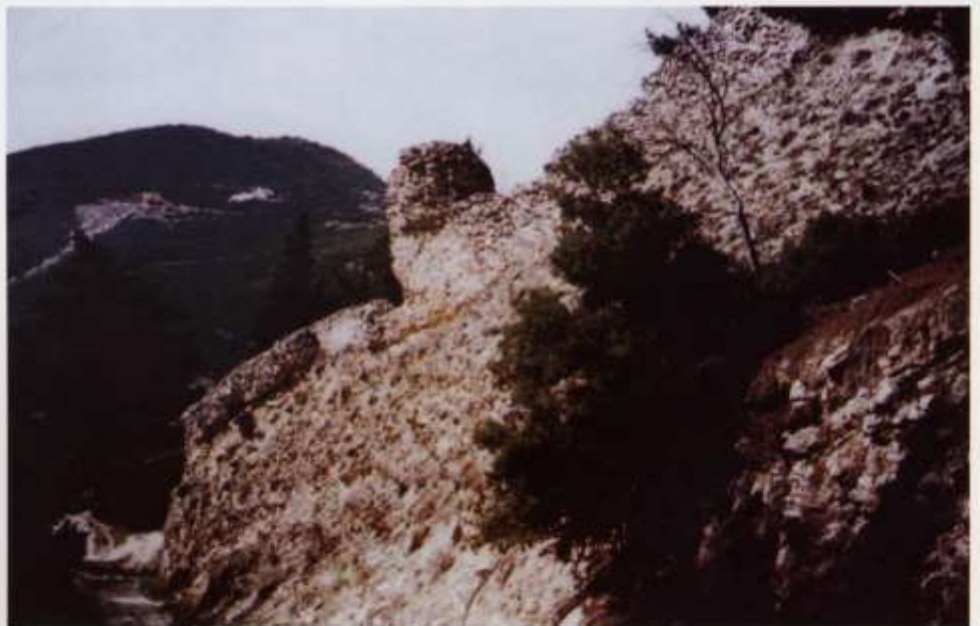
The pathology of the remaining parts was carefully recorded and transferred to the relevant drawings (plans 7, 8). The most common decay at the remaining parts is weathered joints in depth, loose masonry and extended masonry demolition (figure 23) at the lower parts of the walls, threatening the superstructure with collapse (figures 15, 19, 20, 26). It has been observed that this type of damage appears mainly at the base and top of masonry, while the part in between is preserved at a better condition (figures 19, 20, 22). This could be partly attributed to ground condition and water action, together with frost that characterizes its climate during the winter. Another decay most commonly met is the detachment of whole parts of the face of masonry. In many cases it is due to the inadequate bonding between the core and the face, together with the bad quality of the ground, where the foundation is based (figure 25).

figure 25: Southeast part-Inner enclosure. Most of the external part (first phase) has collapsed.

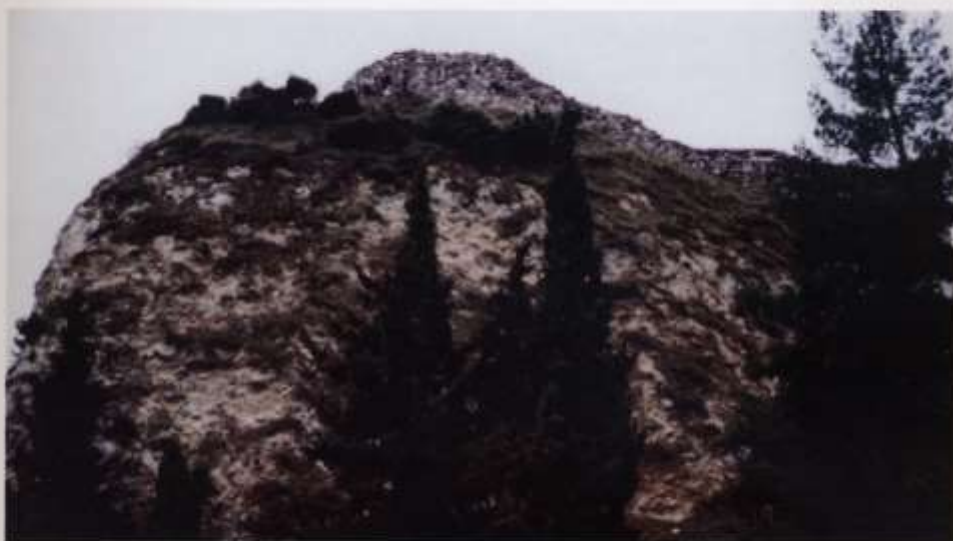
figure 27: Acropolis. Northeast part. The strong inclination and the quality of the ground.

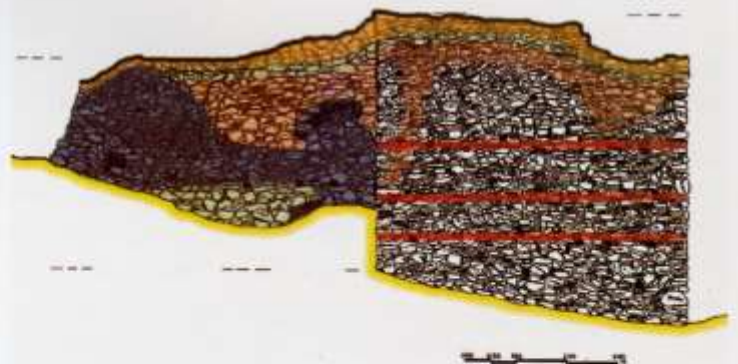
Plan 10: Inner enclosure. Rectangular tower and part of the walls. Proposals for their repair.

Προστατευτική στρώση λιθοδομής Sacrifice stone layer	 	Συγκόλληση ρωγμών Crack repair
 	Αντικατάσταση ξυλοδεσιών Replacement of timber ties	 	Ανάκτηση καταστραμμένης τοιχοποιίας Rebuilding of demolished masonry
 	Προστατική καθαίρεση & ανάκτηση Careful removal of loose masonry and rebuilding	 	Απομάκρυνση βλάστησης - στερέωση λιθοδομής Vegetation removal and masonry repair
 	Βαθιά αρμολόγημα Joint pointing in depth	 	Ανασκαφική έρευνα για την αποκάλυψη θεμελίων Excavation for the reveal of foundations
