STUDIES in ANCIENT STRUCTURES

Proceedings
of the 2nd
International
Congress

THE FORTMED EC PROJECT. A Holistic Approach for the Restoration of Castles and their reuse for the Socioeconomic Development of the Around Area. The Castle of Serbia.

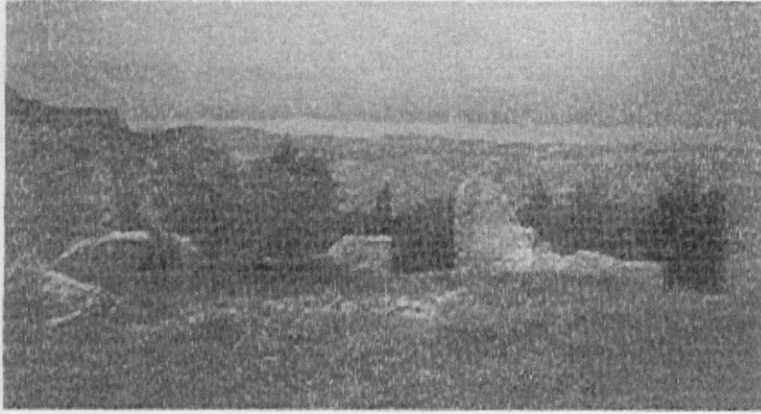
Figure 1. Castle of Servia. A view from Acropolis.

Acropolis was the last line of defense. There existed the house of the sovereign and military buildings. Some remains of them are still visible. Acropolis has a quadrilateral form. Two rectangular towers preserve most of their height. One of them was partly demolished by the earthquake of 1995. The foundation of another triangular tower is visible.

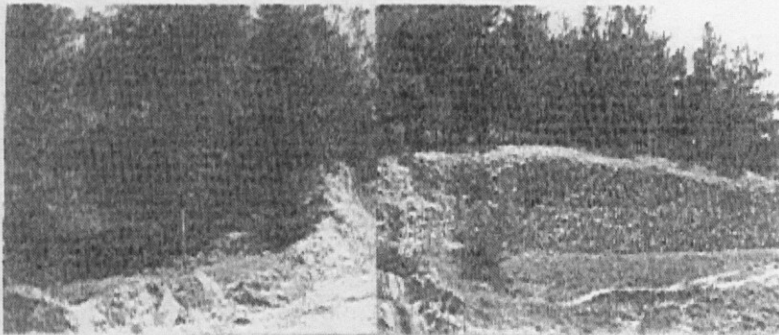
Figure 2. Parts from the inner enclosure.

The inner enclosure is better preserved. It has a polygonal form and it was the second line of defense and the shelter for the population, in case of capture of the outer part. It was thinly inhabited. The ruins of buildings, which are sparse, prove this.

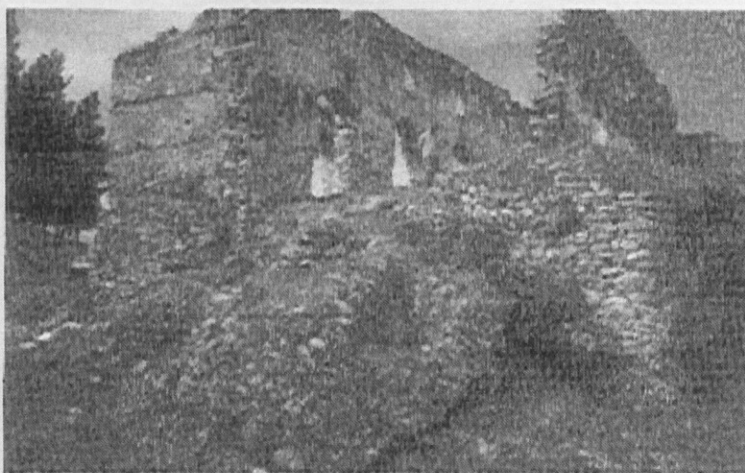
Figure 3. Basilica of Catechized.

Consolidation works were mainly focused on churches and small parts of the walls to avoid collapse. The church of Ag. Anargiri has been fully conserved. The conservation of mural paintings was also included. A major plan for the restoration of the basilica of Catechized has started five years ago. Besides consolidation of the existing structure, the project includes partial rebuilding of missing parts and partial covering, for the protection of frescoes on the walls and graves revealed during excavation works, under the floor of the central aisle. The systematic analysis and record of the old materials as well as the design of the new repair materials (in order to be compatible with the old ones) is made in the frame of the FORTMED EC project.

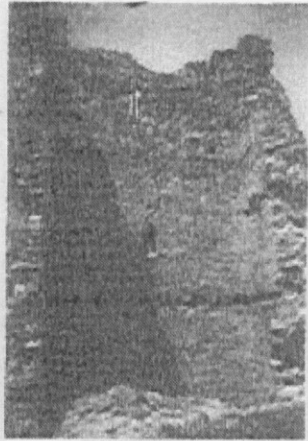
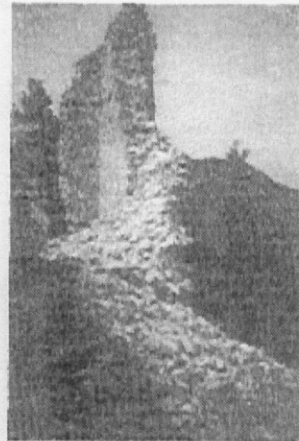
Figure 4, 5. Towers from Acropolis. State of preservation.

The castle suffers from extended demolition. Furthermore cracks of different types and width, inclination from vertical, weathered joints, loose masonry and losses of adhesion of the building materials are problems, which appear to most of its parts.

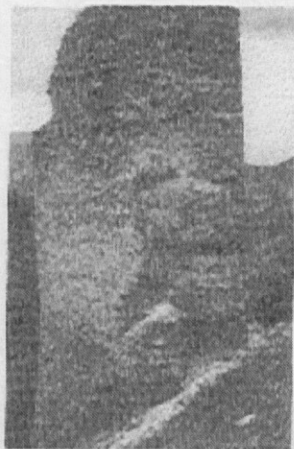
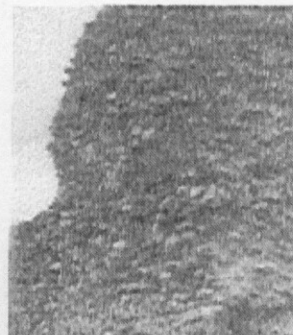
Figure 6, 7. Tower from Acropolis and its state of preservation.
Detail from loose masonry.

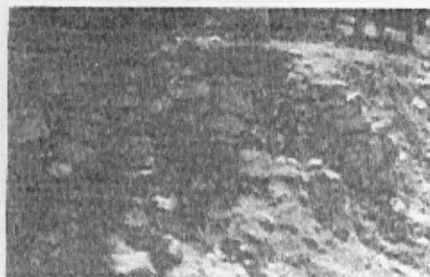
Figure 8. Detail showing roots action.

The main cause of deterioration is abandonment and neglect. Human action was another main cause of decay. The reuse of building materials, during the centuries, for the construction of new buildings was a very usual action. At the period between the two world wars a forest with pine trees was created to cover the hill of the castle. The roots of the trees must have caused serious damage to the remains. Moreover, earthquakes, weathering, ageing, climatic conditions and especially frost, as well as the bad quality of ground are some other causes of decay.
