# STUDIES on HISTORICAL HERITAGE

**TRANSFORMATIONS THROUGH HISTORY:  
THE MARKOU WATERMILL IN VERIA (GREECE) AND ITS  
CONVERSION TO BYZANTINE MUSEUM**

K. Theologidou

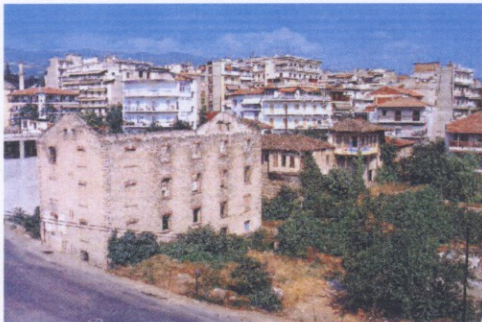
Figure 1. The watermill before the restoration works

The image of the building in 1991, when the conservation plan started, was disappointing (Figure: 1). It was burnt in 1981 and what were left from it were the external walls and a metal construction of columns and beams, badly distorted.

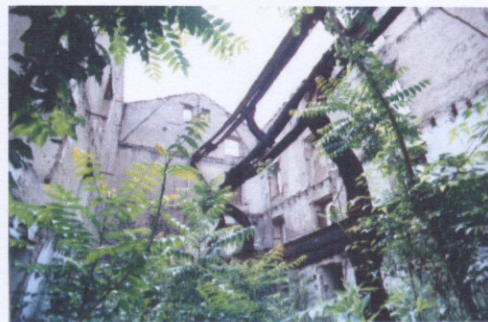
Figure 2. The internal space before the restoration works

Though the internal space was demolished by the fire, traces on the walls and the distorted iron element, together with old photographs, gave evidence about its initial form and construction (Figure: 2). This evidence made possible reliable reconstruction drawings, valuable to the conservation plan for its restoration and reuse.

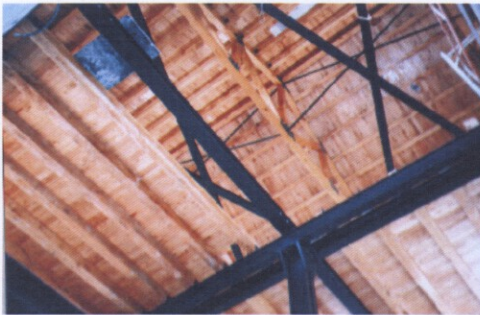
Figure 3 Reconstruction of metal carrying system, timber floors and roof

The values of the building, together with the reliable reconstruction drawings, lead to the decision to rebuild the carrying system of the construction, in simpler form and details, so that at short distance the contemporary of the construction is distinguished (Figure: 3). In that way the material evidence of the innovating technology of the period is preserved and highlighted. Small parts of the original iron construction are displayed at the courtyard of the museum.

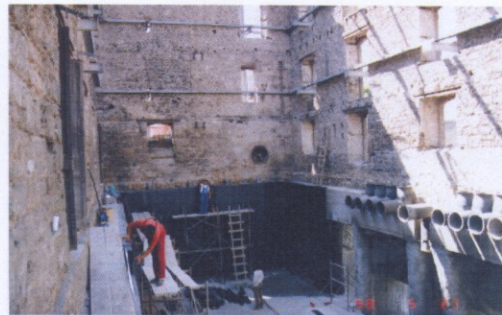
Figure 4 The construction of a basement in the mill

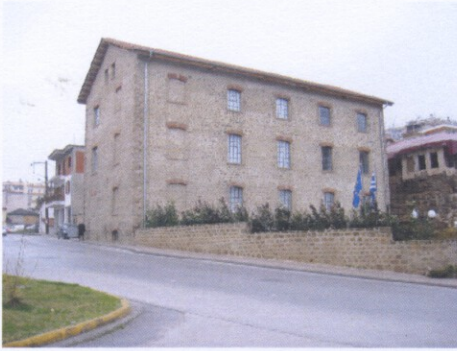
Figure 6 The transformed mill to a museum

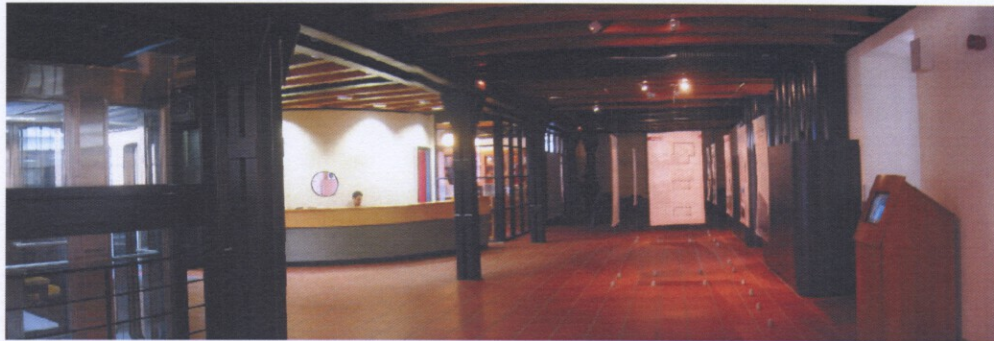
Figure 8 Ground floor, after the restoration works

The internal space of the mill, after the restoration works, was imposing (Figure: 8). Therefore, the exhibition design had additional difficulties. It should respond to the demands of a museum exhibition where the focus is on the exhibits, to the display of the building itself as a reminder of the later history of the city and to the museology study, which entailed the division of the space. The aim of the plan was to get on a balance with different levels of view. The exhibits should gather the concentration of the visitor, so planning should focus on them, highlighting their importance and the scenario of the museology study. At a second level, the visitor should have the image of the internal space of the old factory, after its restoration. Therefore, all the constructions for the division of the space should have the minimal dimensions to correspond to their role. At a third level, the constructions themselves and all exhibition equipment should be elegant, equivalent to the qualities of the building and the excellent art of the exhibits.
